Road Damage Analysis on Brigjend Katamso Road - Berbek Road – Wadung Asri Road with Sdi Method

Rifki Amirullah¹, Ibnu Sholichin²

Civil Engineering Study Program, Faculty of Engineering, National Development University "Veteran" East Java, Indonesia^{1,2}

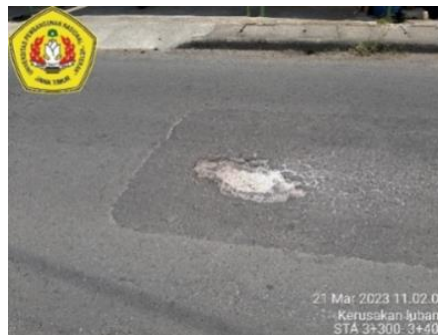
Figure 1. Examples of Whole Damage at Research Locations (Observation Results)

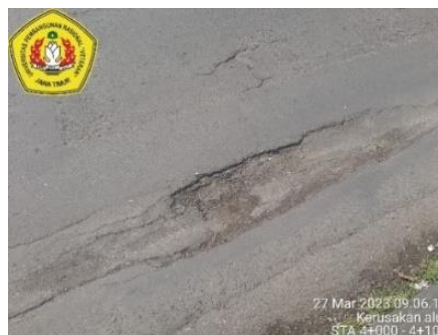
Figure 2. Examples of Flow Damage at Research Locations (Observation Results)

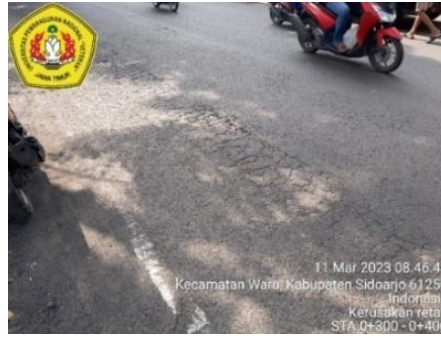
Figure 3. Examples of Crack Damage at Research Locations (Observation Results)

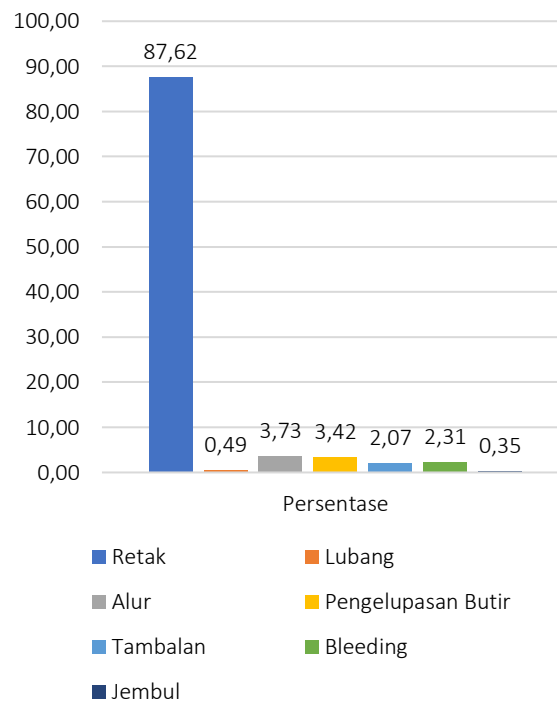
Figure 4. Percentage of Road Damage (Results of data analysis)

It can be seen from Figure 4 that the most dominant damage is crack damage. This makes crack damage the most influential damage to the calculation of road condition values. The results of the SDI values for each segment are presented in table 9 as follows.

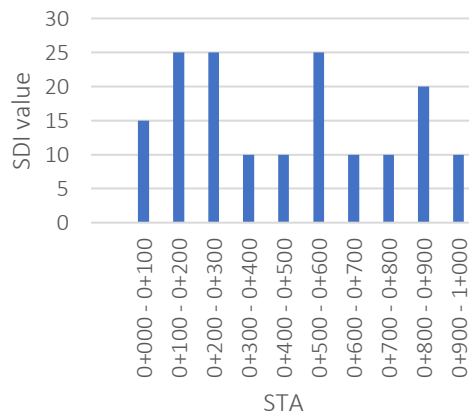
Figure 5. SDI Value in Segment 1 (Results of data analysis)

From Figure 5 it can be seen that the SDI values in segment 1 are all below 50 (in good condition) and the highest damage conditions are at STA 0+100 – 0+300 and STA 0+500 – 0+600 which have an SDI value of 25.

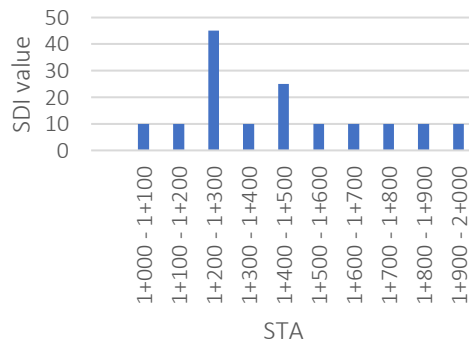
Figure 6. SDI Value in Segment 2 (Results of data analysis)

From Figure 6 it can be seen that the SDI values in segment 2 are all below 50 (in good condition) and the highest condition of damage is located at STA 1+200 – 1+300 which has an SDI value of 45 (almost reaching medium condition). The SDI values in segment 3 are presented in Figure 7 as follows.

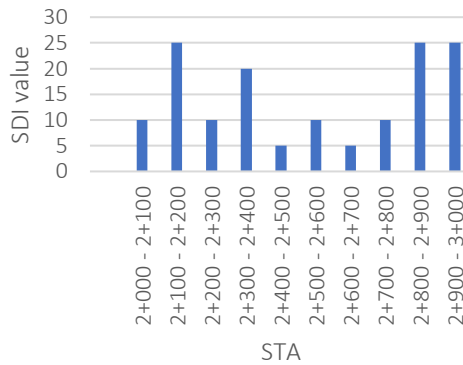
Figure 7. SDI Value in Segment 3 (Results of data analysis)

From Figure 7 it can be seen that the SDI values in segment 1 are all below 50 (in good condition) and the highest damage conditions are located at STA 2+100 – 2+200 and STA 2+800 – 3+000 which have an SDI value of 25.

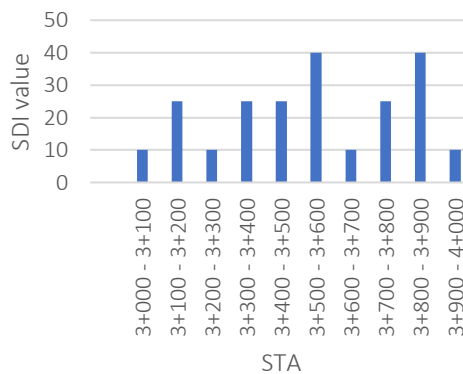
Figure 8. SDI Value in Segment 4 (Results of data analysis)

From Figure 8 it can be seen that the SDI values in segment 4 are all below 50 (in good condition) and the highest condition of damage is at STA 3+500 – 3+600 and STA 3+800 – 3+900 which have an SDI value of 40 (almost reaches medium condition).

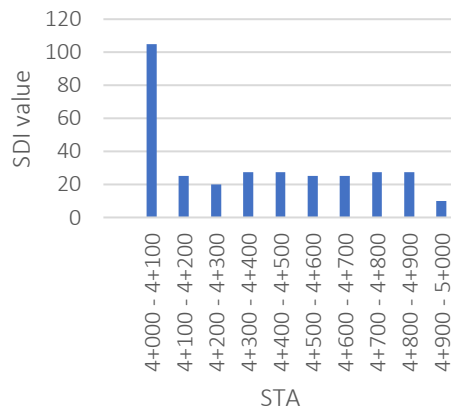
Figure 9. SDI Value in Segment 5 (Results of data analysis)

From Figure 9, it can be seen that almost all of the SDI values in segment 5 are below 50 (in good condition). Only one STA has the number 105 (in slightly damaged condition), namely STA 4+000 – 4+100.

The form of treatment required for the Jalan Brigjend Katamso – Jalan Raya Berbek – Jalan Raya Wadung Asri STA 0+000 – 5+000 section according to the SDI method (table 8) is routine maintenance and periodic maintenance. Routine maintenance is carried out on roads that are in good condition, namely on STA 0+000 – 4+000 and STA 4+100 – 5+000 (based on table 9). Meanwhile, periodic maintenance is carried out on roads that are in a slightly damaged condition, namely at STA 4+000 – 4+100 (based on table 9)(Yusup, 2020).
